# Effects of Elevated Temperatures on RCC Beams: Damage Assessment & Performance Evaluation

This study examines how high temperatures affect reinforced concrete (RCC) beams, emphasizing how thermal stresses alter material characteristics and structural performance. According to experimental findings, there is no discernible harm up to 300°C to 400°C; nevertheless, at 500°C, discoloration starts, mild spalling starts at 600°C, and large fractures with light brown discoloration start to emerge at 700°C. Between 300°C and 700°C, compressive strength drastically decreases, ranging from 20% to 80%. Finding fractures, spalling, and strength loss in steel reinforcing is crucial, according to post-fire damage assessment. Remaining strength and structural integrity were assessed using non-destructive testing instruments including the Ultrasonic Pulse Velocity meter and Rebound Hammer. In order to restore fire-damaged RCC elements and guarantee structural integrity and load-bearing capability, strengthening techniques such as the use of GFRP sheets were also investigated. This comprehensive analysis provides insights into performance evaluation and effective repair techniques for fire-expos

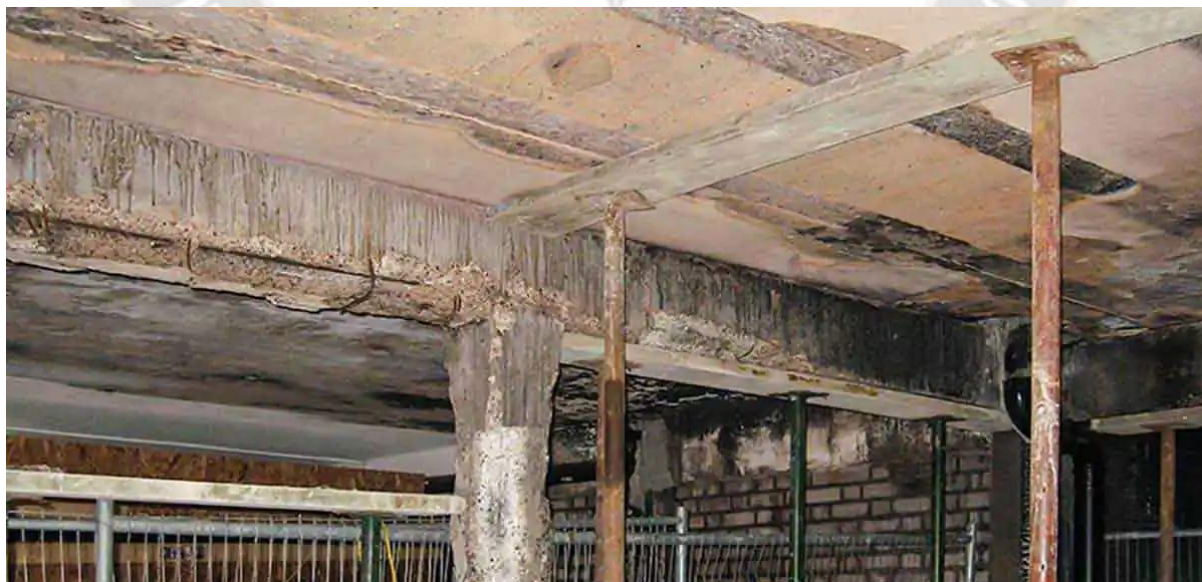
Figure 1: beam Specimen

To ascertain the new composite's textural behavior,  $150 \times 100 \times 150$  mm beam specimens were evaluated. The ten M25 grade no beam specimens exhibited identical failure mechanisms and had the same tension reinforcement ratio ( $\rho_t$ ) and 8mm dia stirrup spacings of 100mm c/c. In the compression face, the concrete crushed the two beams. the concrete's mixing percentage. is used as mixing water here. A summary of the mechanical characteristics of hardened concrete after 28 days of moisture curing is provided. After the usual 28-day curing period, cyclic wet and dry conditions were used to mimic the corrosion process under salt attack.

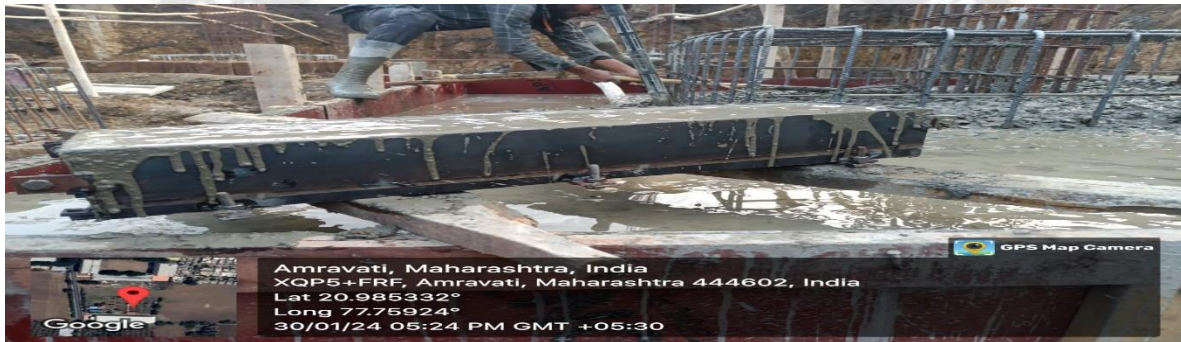
Figure 2: mould

The steel mold that was used in the creation is 60 cm by 100 cm by 150 cm. To guarantee the placement of the reinforcement, cover blocks are positioned at the sides and bottom of the mold. For added strength and stability, the beam is strengthened with two bars of 12 mm in diameter at the top and bottom, as well as stirrups of 10 mm in diameter.

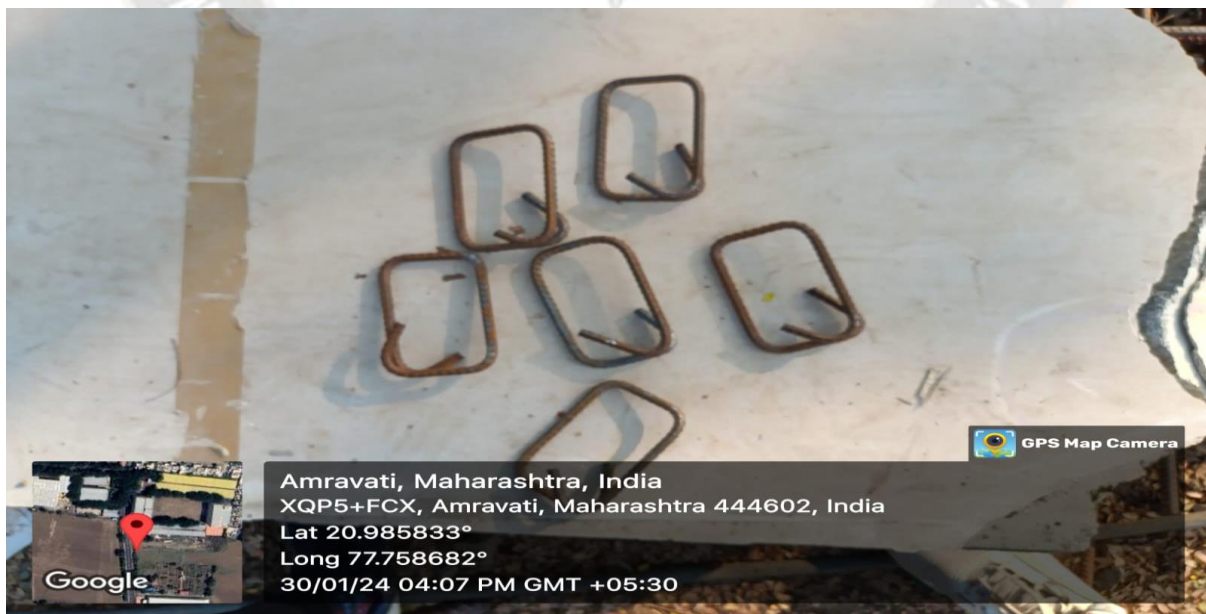
Figure 3: Stirrups

**2. Stirrups:** To properly hold reinforcement, stirrups with a diameter of 10 mm are used. Four stirrups spaced 40 mm apart are used in a single beam.

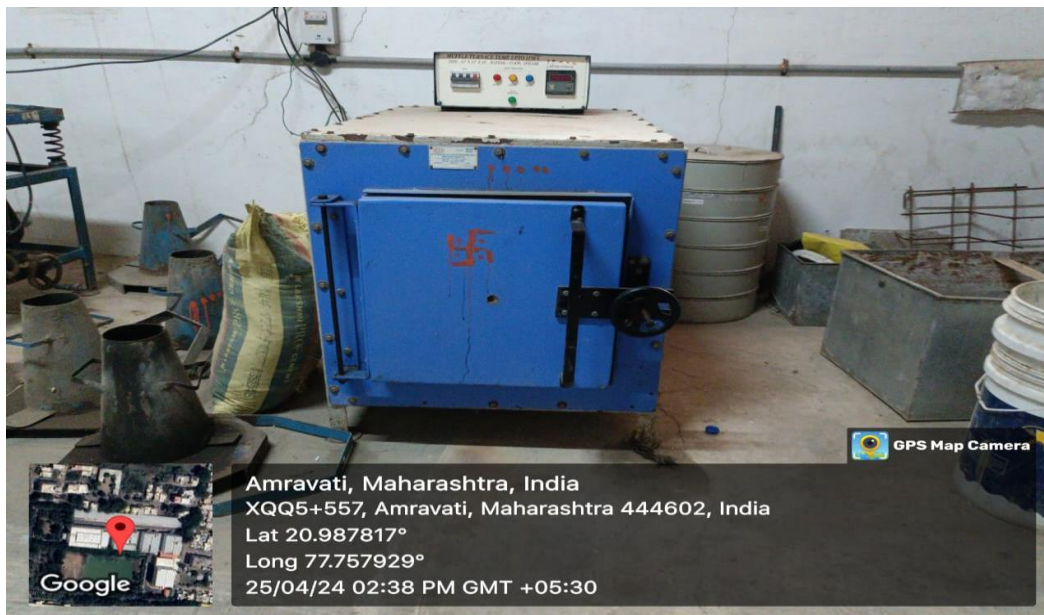
Figure 4: Muffle Furnace

Depending on what kind of heating elements are employed in its construction, a muffle furnace can reach a variety of maximum temperatures. With a typical temperature range of 0°C to 1200°C, these furnaces are frequently used for high-temperature applications and can be used for a range of industrial and laboratory activities.

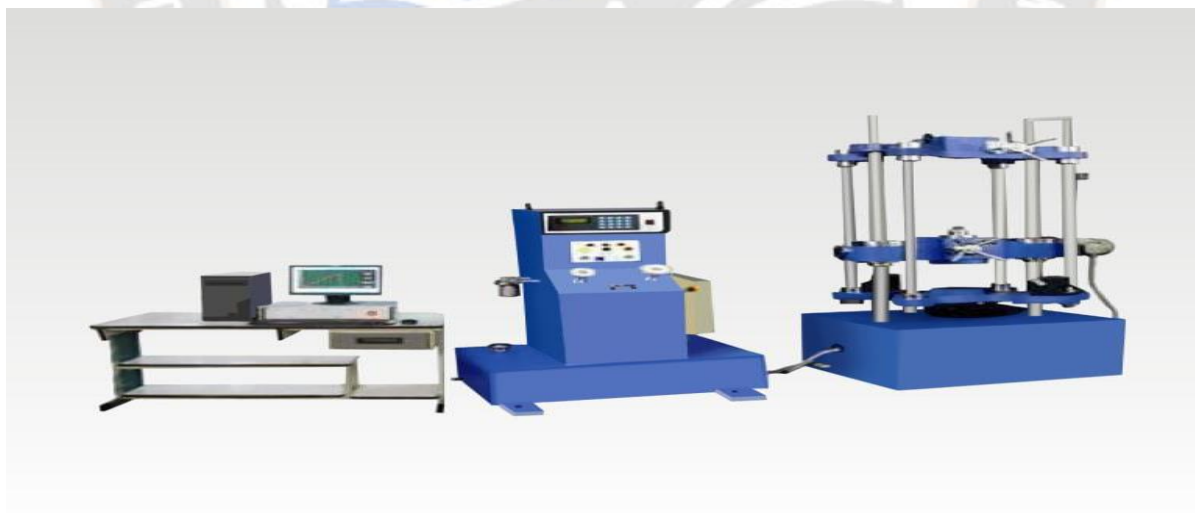
Figure 5: universal testing machine

**4. Universal Testing Machine (UTM):** A UTM is a multipurpose mechanical testing device that is used to assess the mechanical characteristics of materials under bending, torsion, compression, and tension. Tensile strength, compressive strength, modulus of elasticity, and other

properties can be determined by applying controlled loads to specimens and monitoring their reaction. UTMs are frequently used in manufacturing facilities, research institutes, and materials testing labs to evaluate the quality and performance of materials in a variety of industries.

In order to test a beam with a Universal Testing Machine (UTM), the specimen must be prepared in accordance with standards, fixed firmly in the UTM, and the machine must be configured with the proper test parameters. The UTM records data such load, displacement, and time while progressively applying load in tension or compression. In order to assess mechanical attributes such as ultimate strength, yield strength, and elasticity, engineers examine this data. To evaluate the structural integrity of the beam, the test is conducted repeatedly until failure or a predetermined endpoint is reached. The results are recorded in a comprehensive report.

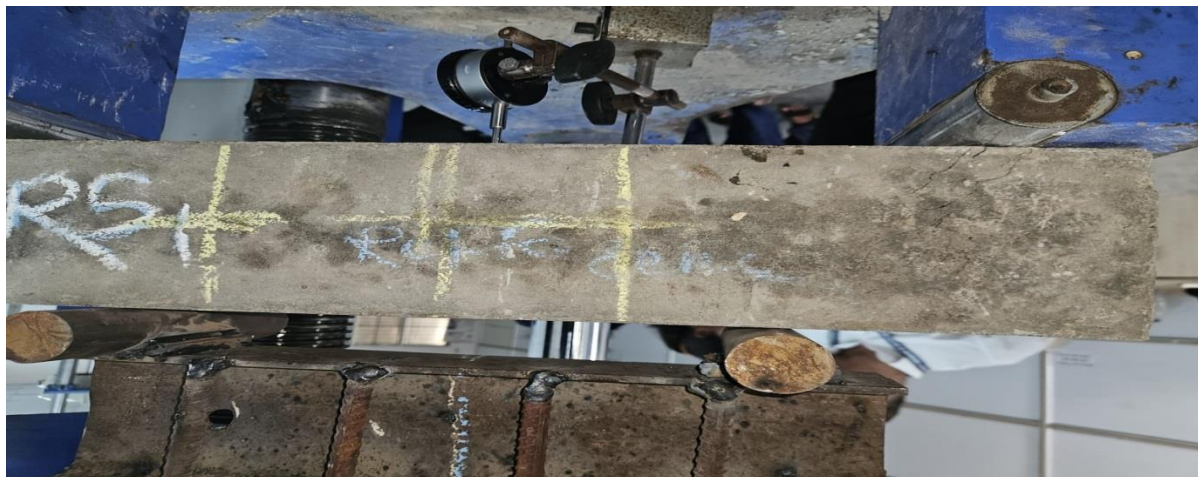
Figure 6: Reference Specimen one

This reference specimen serves as a point of reference. The fired beam is compared to this reference specimen. Following testing, all findings are compared to RS1, and the remaining beams are fire supplied differently utilizing a muffle furnace.

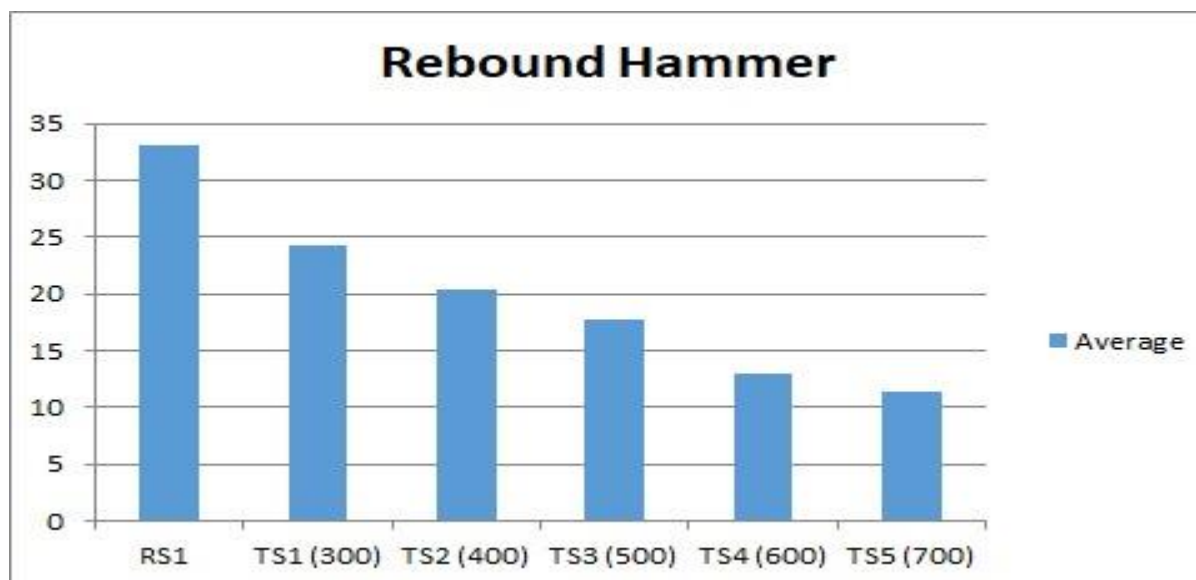
Figure 10: Rebound Hammer graph

A concrete beam's strength and endurance may be significantly impacted by changes in its material qualities brought on by fire exposure. One popular technique for determining the strength of concrete is the rebound hammer test. After a concrete beam has been exposed to fire, the rebound hammer test can be used as follows.

In summary, the test results suggest that, up to 300°C to 400°C, beams do not exhibit any discernible temperature effects. At 500°C, however, discolouration happens without spalling. At 600°C, there is some spalling, but at 700°C, there are significant fissures and mild brown staining. Additionally, as temperatures rise, both rebound numbers and compressive strength decline. Between 300°C and 400°C, compressive strength decreases by 20% to 80%, and at 700°C, it decreases by 80%.
